**Malcolm Morgan Marine / M³
Marine Electrical, Corrosion & Engineering Services**

**Limited Corrosion / Electrical / Shore Power Inspection
Honokohau Small Craft Harbor
May / June 2017**

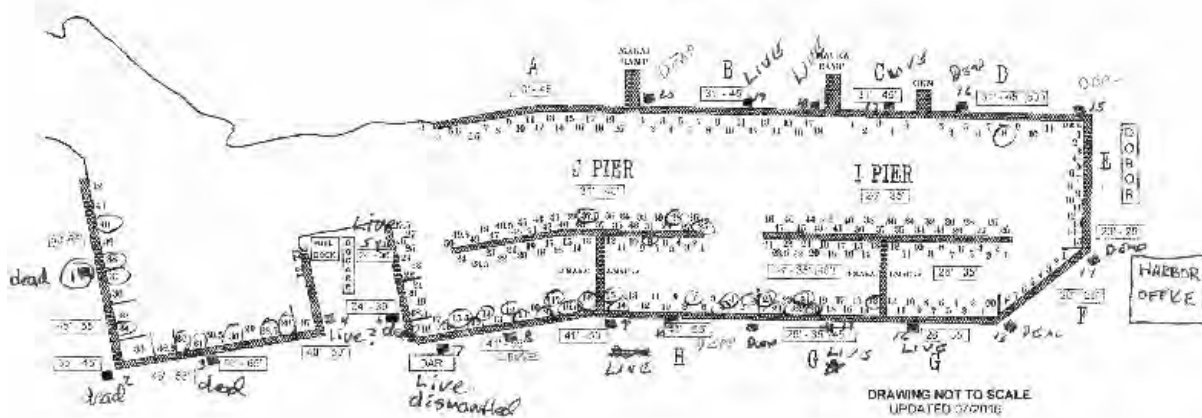
HONOKŌHAU SMALL BOAT HARBOR
KAILUA-KONA, HAWAII

✗ = doesn't work could still be electrified

20 ■ - Electric coin meter

36 ○ - Privately metered electricity
